Exhibit C

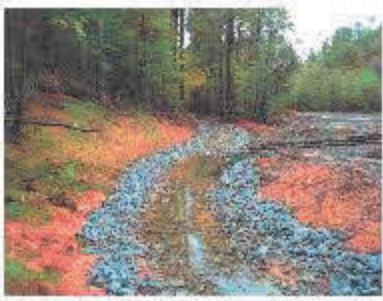
Remediated OLC3

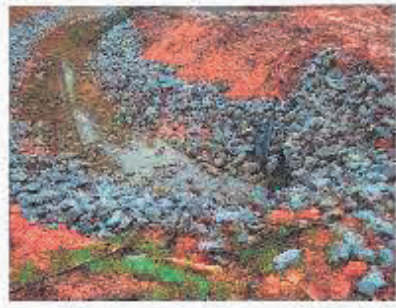
Remediated OLC3

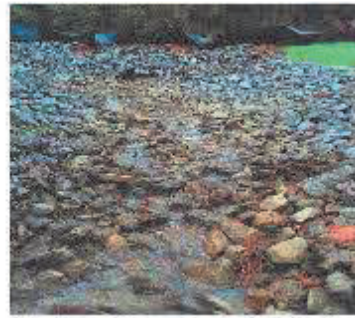
Remediated OLC3

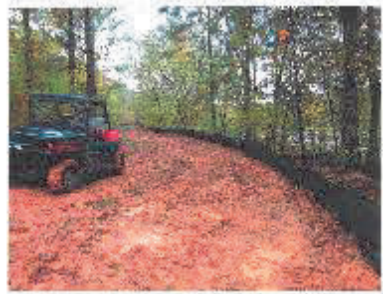
Silt fence BMP

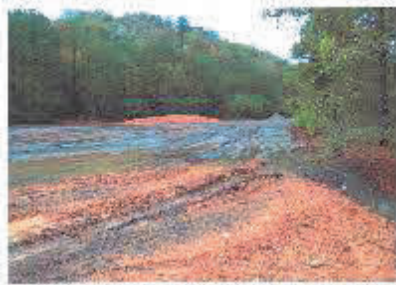
Lower Basin

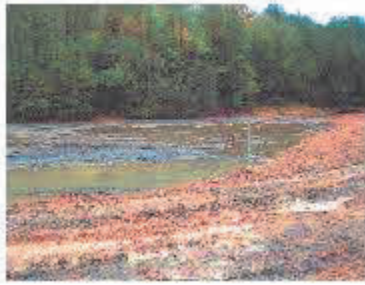
Lower Basin

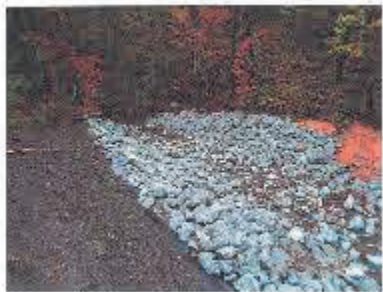
Upper Cross Drain OLC2

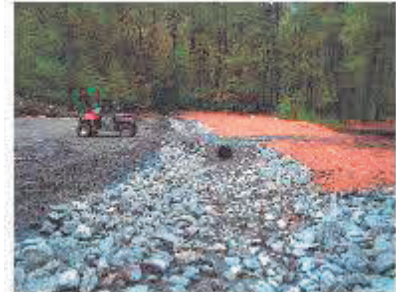
Upper Cross drain OLC2

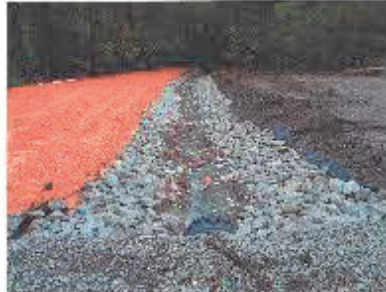
Upper Cross Drain OLC2

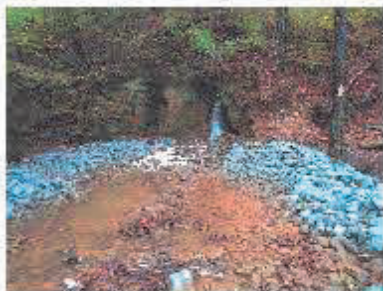
Water Fall Area Head of OLC3

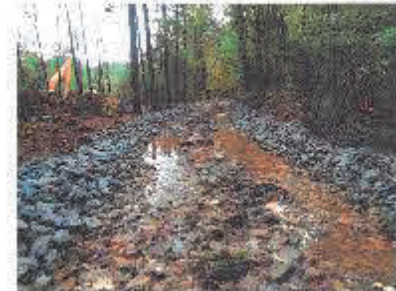
Remediated OLC3

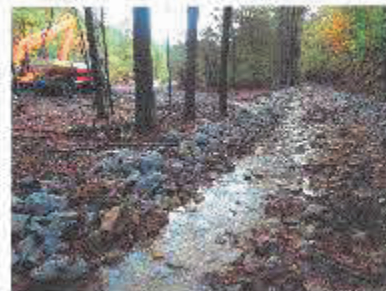
Remediated OLC3

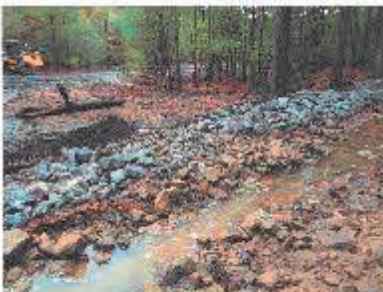
Remediated OLC3

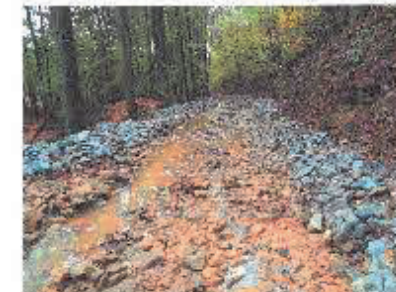
Remediated OLC3

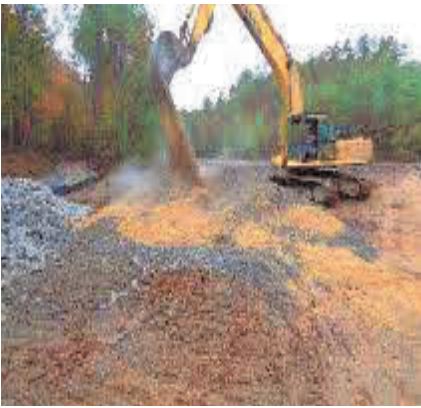
Prep Bio-Reactive Material In OLC4

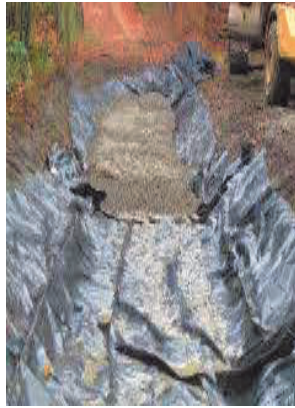
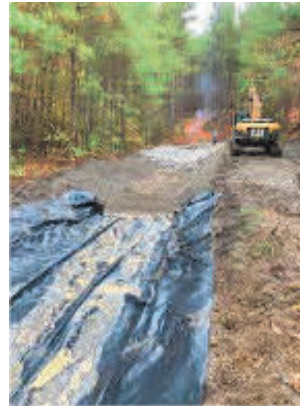
Installing Bio-Reactive Material in OLC4

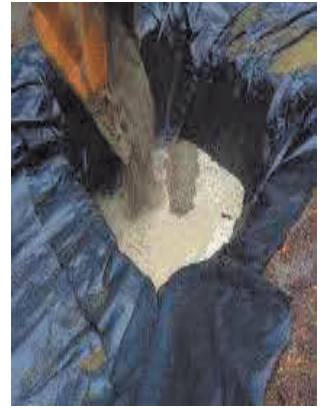
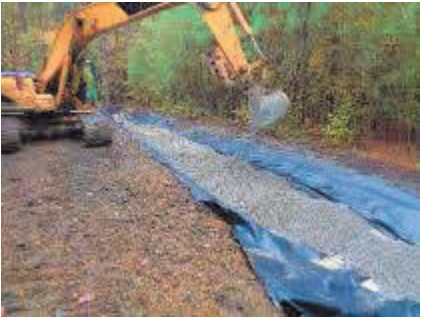
Lining with Bio-Reactive Material OLC4

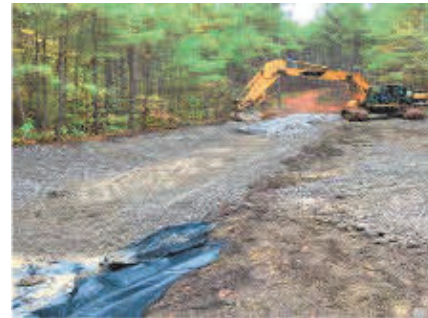
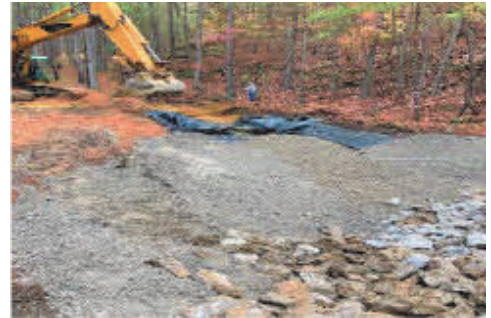
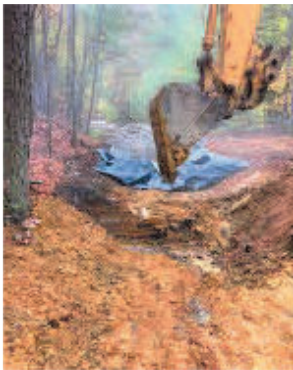
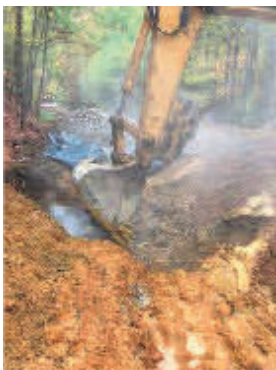
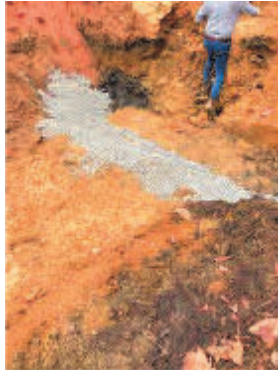
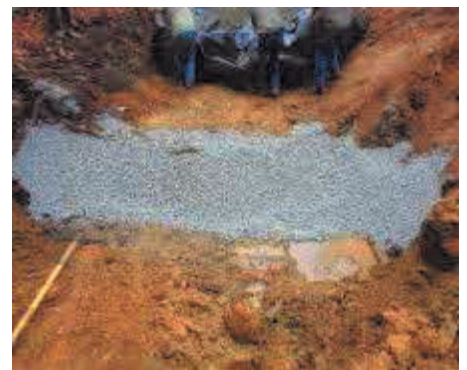
Digging and Installing a Cutoff Trench with bentonite in the OLC4 at SEEP discharge location

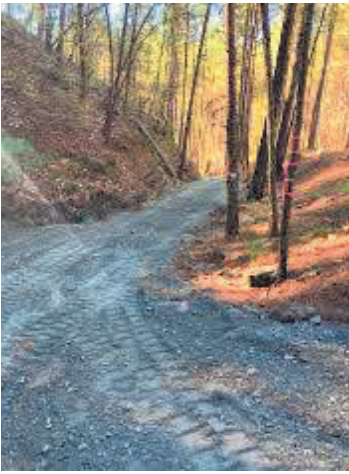
Extending the OLC4 up into the most northwestern gullies

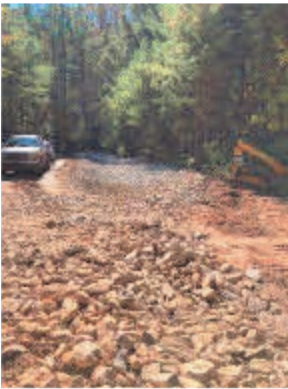
Installing Limestone on top of Mix of Brewer's Mash

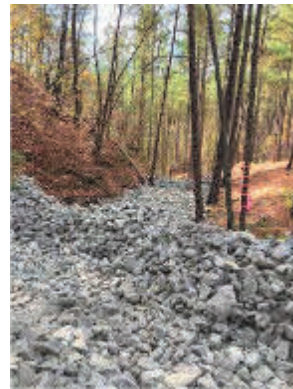
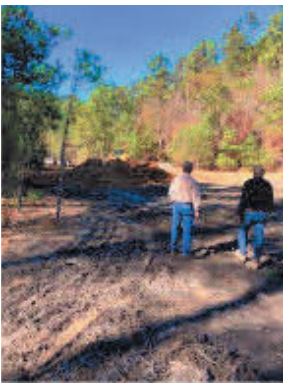
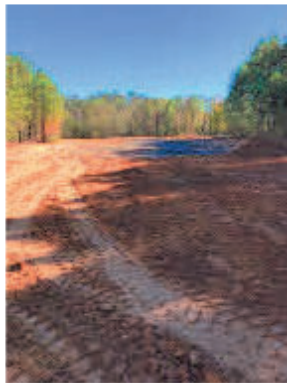
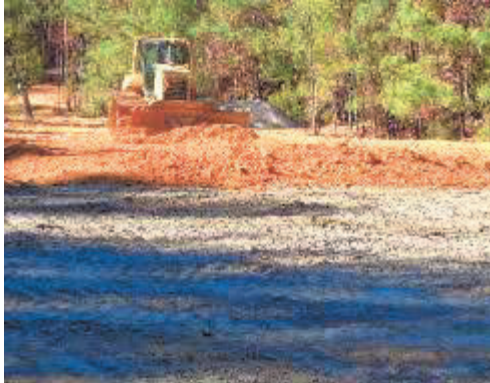
Clay/Topsoiling Activities Lower Basin

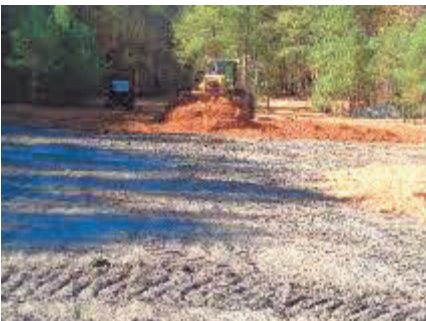
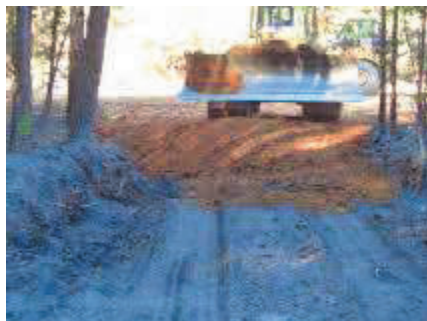
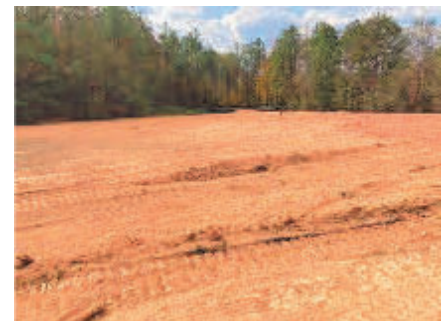
Clay/Topsoiling activities Lower Basin

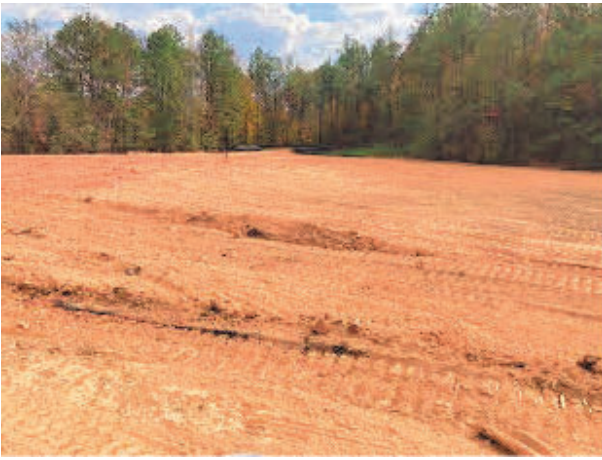
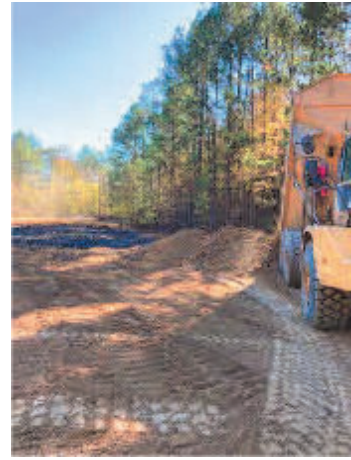
Clay/Topsoiling activities (Lower Basin)

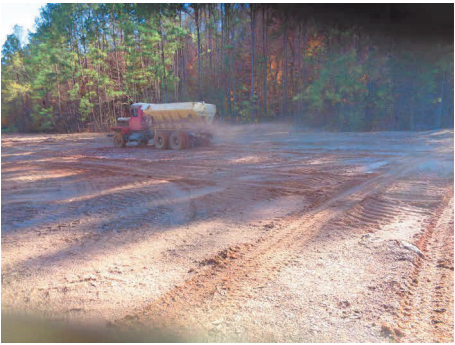
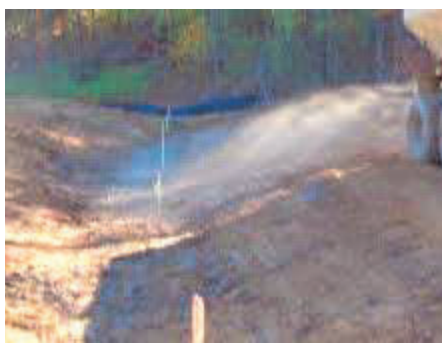
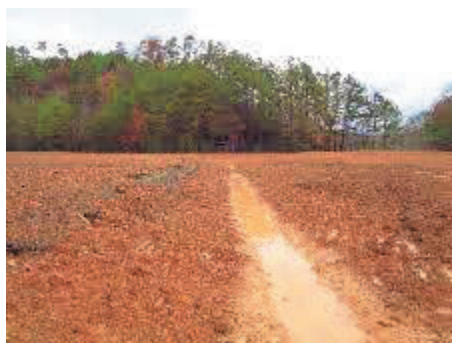
Installing cross-drain channels in Lower Basin (1 of 4)

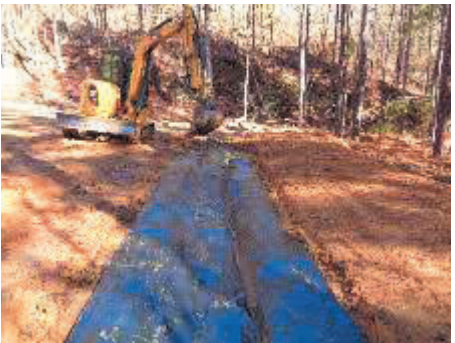
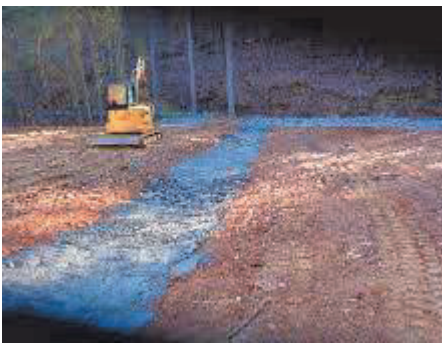
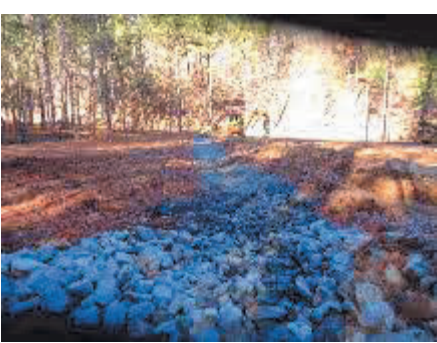
Re-liming Clay/Topsoil Cross Flow Channel Disturbance (Lower Basin)

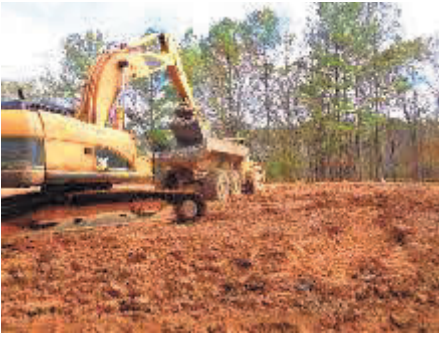
Installing Cross Drain Impervious Liner, Calcitic Limestone, and Calcitic Rip-Rap (Tie into OLC3)

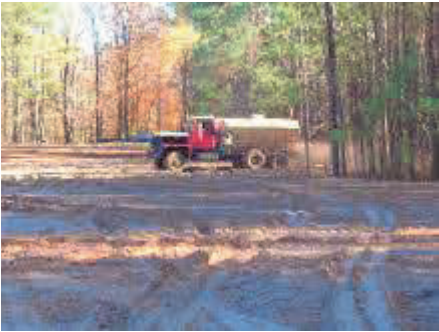
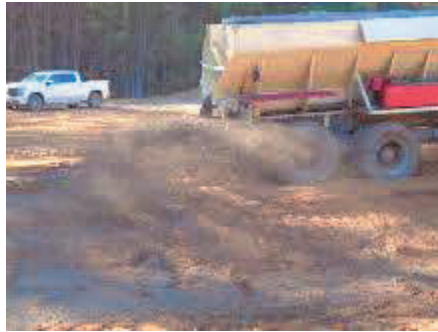
Clay/Topsoiling activities (Upper Basin)
